Irresponsible of Statoil

Having reviewed all the available information, Bellona feels it is irresponsible of Statoil to resume production at Gullfaks C.

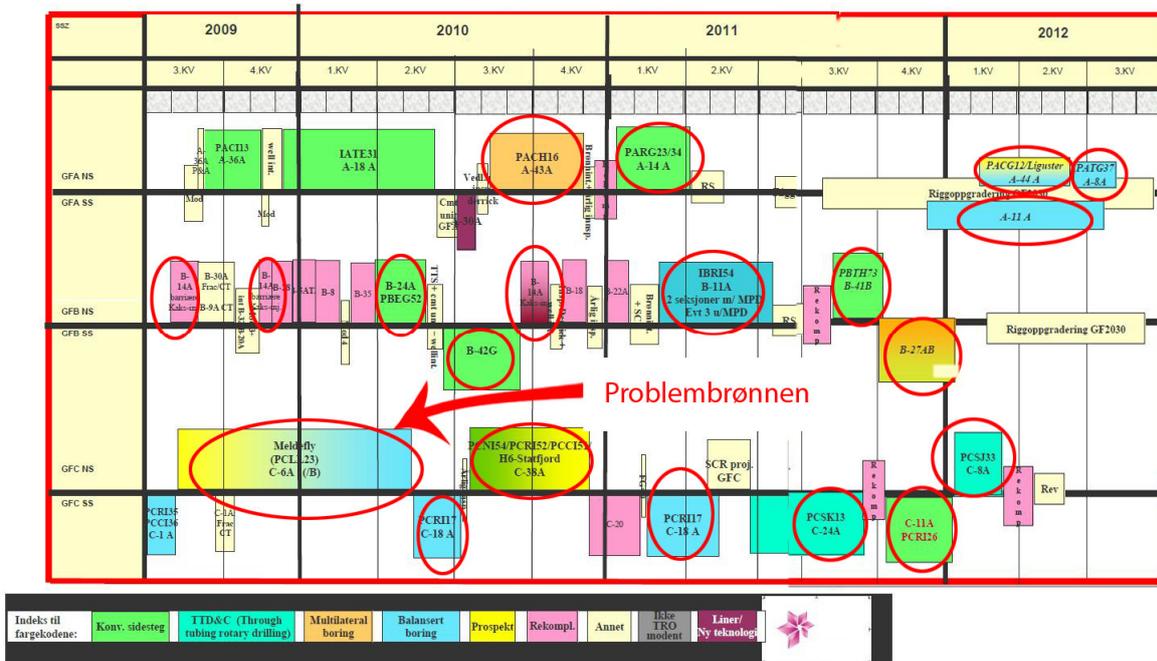
Figure text **Figure 2:**

Statoil's drilling plan for the Gullfaks area for 2010 and 2011. New wells and side-tracks are encircled in red.

For the Gullfaks area drilling of 16 new side-tracks and well-operations and one cutting injector (see Figure 2) need to be revised in light of the leak at Gullfaks.
